Mr. Lee Heeren  
Illinois Environmental Protection Agency  
4302 North Main  
Rockford, Illinois 61103  
Subject: EPA Oversight Inspection Report

**CWA OVERSIGHT INSPECTION REPORT  
ILLINOIS**

<b>Inspection facility</b>	Golden Oaks Farm 27730 W. Bonner Road Wauconda, IL 60084
<b>NPDES permit status</b>	No permit
<b>IEPA inspection date</b>	05/02/12
<b>EPA inspection date</b>	09/05/12

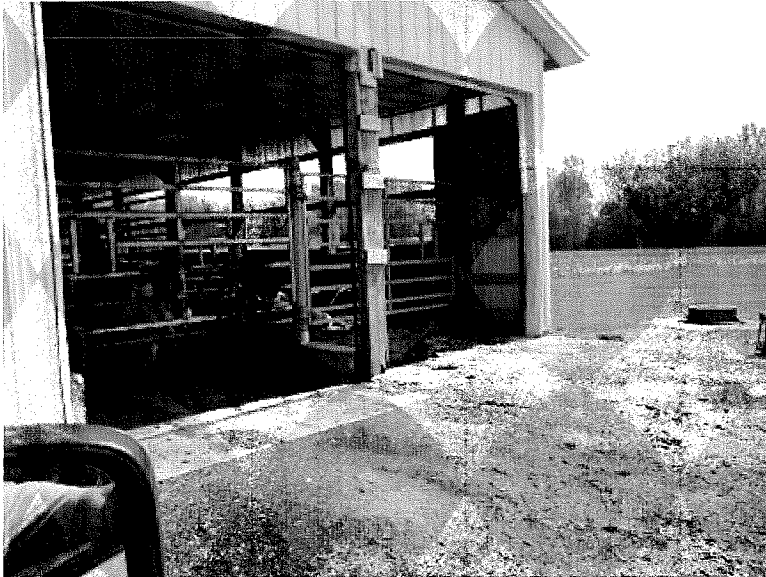
EPA noted an area of manure and process wastewater runoff on the east side of the north barn. While scraping the manure from the barn, it is pushed up against the concrete wall outside the barn. Portions of the wall had been removed to allow for access to the

concrete pad. No curbing is present at the gates to prevent manure and process wastewater from flowing off the concrete pad. No discharge to surface water was observed on the day of the inspection.

IMGP1453: Solid manure is scraped from the north barn and pushed up against a concrete wall.

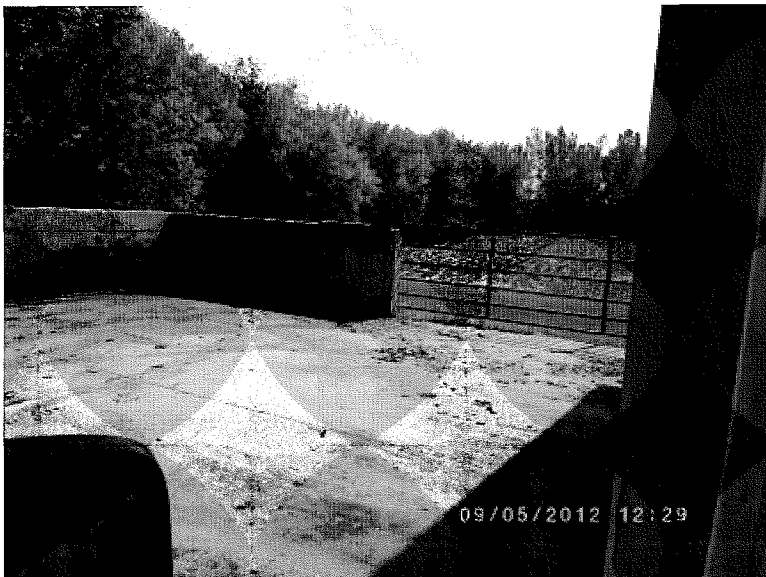
IMGP1454: The portion of wall that is missing allows for manure and process wastewater to run off to the east.

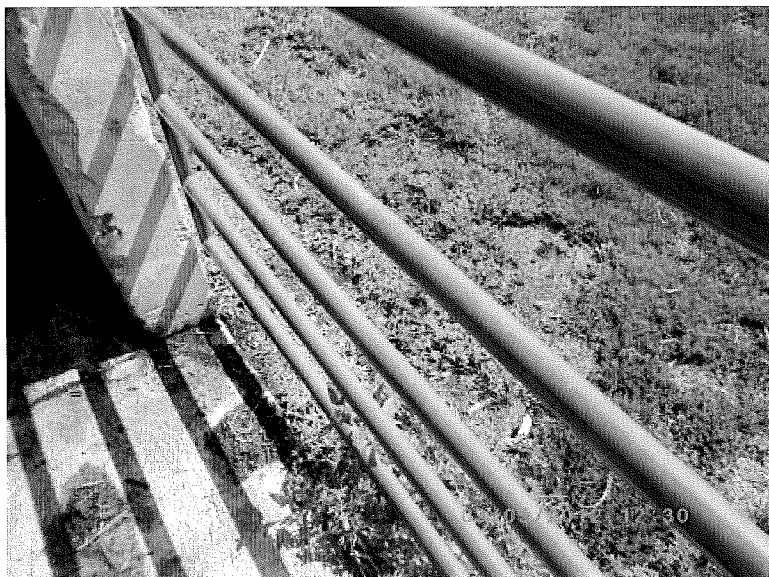
IMGP1455: Manure and process wastewater can run off the concrete pad.  
Location: Darrell Road Facility  
Facing: Down  
Date/Time: 09/05/12 12:30 P.M.

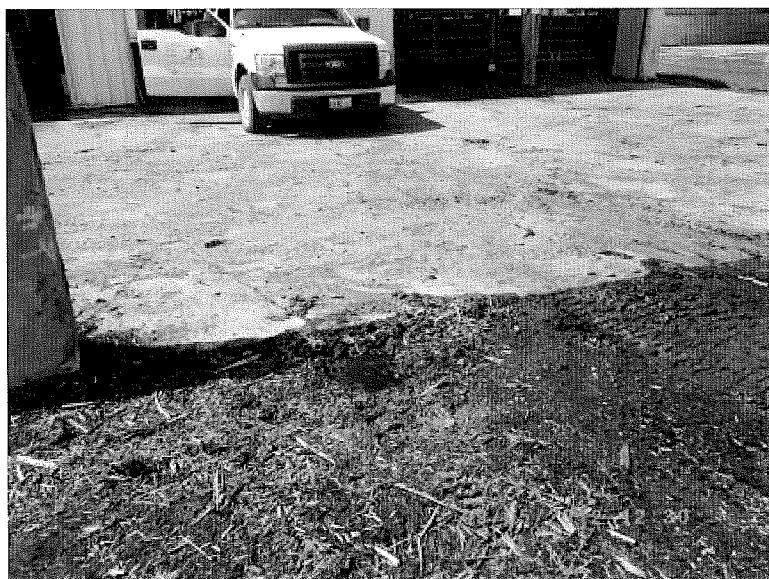
IMGP1456: Manure, spilled feed and process wastewater are not contained on the east side of the north barn.  
Location: Darrell Road Facility  
Facing: Northwest  
Date/Time: 09/05/12 12:30 P.M.

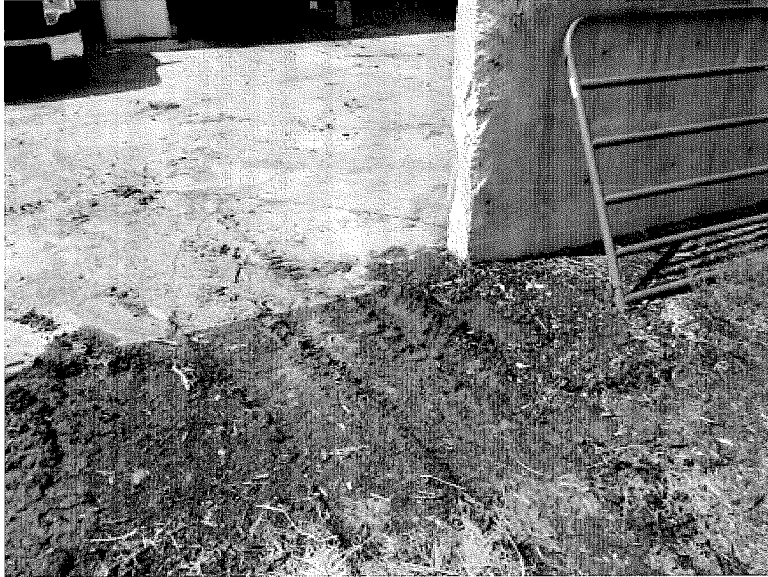
IMGP1457: Manure, spilled feed and process wastewater are not contained on the east side of the north barn.

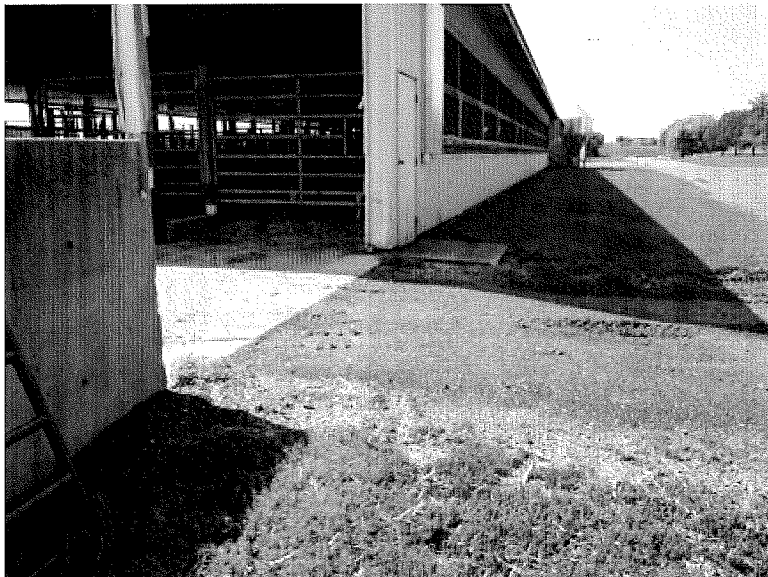
IMGP1458: Truck access to concrete pad can allow manure and process wastewater to run off to the north.

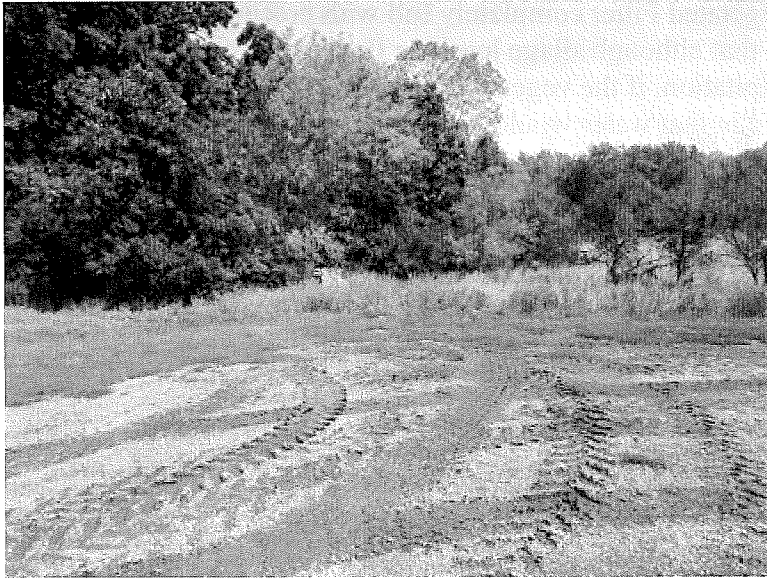
IMGP1459: Denuded area northeast of barns at Darrell Road Facility.  
 Location: Northeast corner of Darrell Road Facility  
 Facing: Northeast  
 Date/Time: 09/05/12 12:31 P.M.

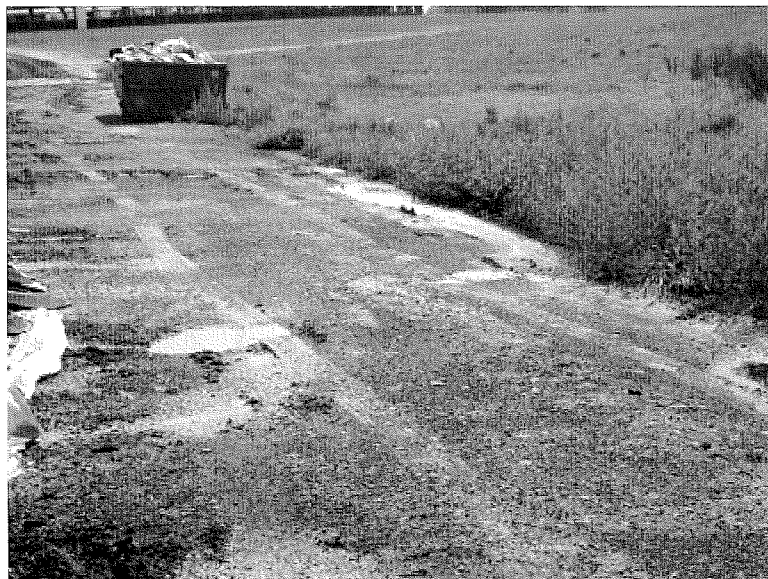
The inspection continued at the Silage Pad of the Dairy, passing through the Compost Facility on the way. The Silage Pad is on the north end of the Dairy. EPA observed silage leachate pooled in the northwest corner of the Silage Pad and a channelized pathway of silage leachate leading to the west to a Vegetated Filter. After approximately 30 feet, the channelization of the leachate was not present anymore. Mr. Patterson stated

IMGP1464: Runoff from Silage Pad channelizes in the northwest corner of the pad.  
Location: Northwest corner of Silage Pad  
Facing: South  
Date/Time: 09/05/12 12:53 P.M.

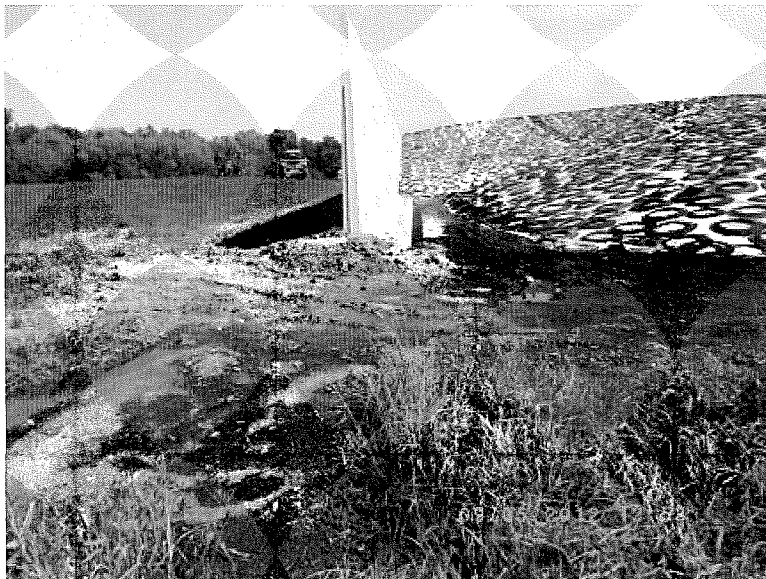
IMGP1467: Runoff from silage is not contained. Runoff flows to vegetated buffer to the west. No discharge to surface water was observed.

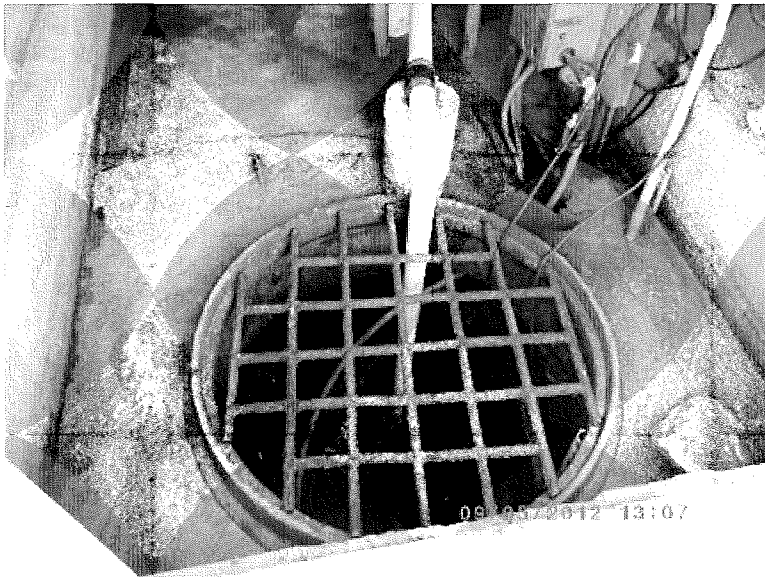
IMGP1479: Liquid from settling basins goes into a manhole and from there it is pumped to the Manure Pond. Power outage would cause manhole to fill up and overflow to Circular Pit.

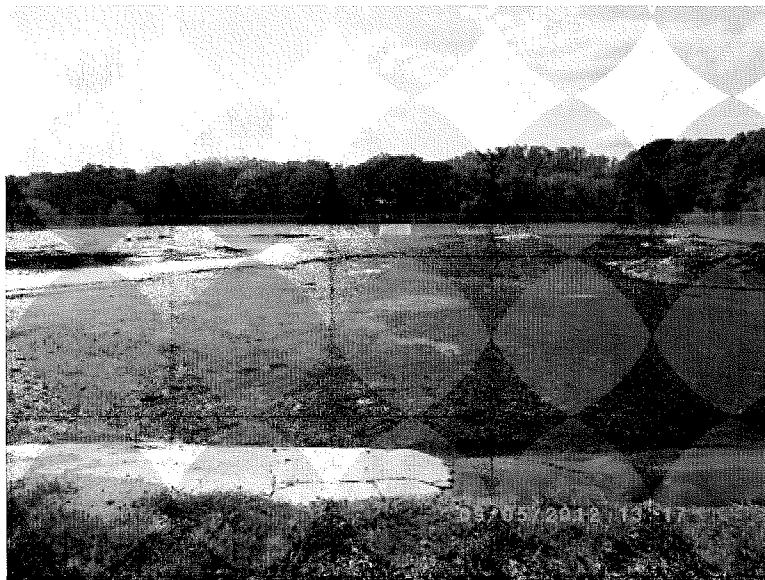
EPA walked the perimeter of the Holding Pond located to the northwest of the Dairy freestall barns. EPA observed several large bubbles in the synthetic liner. Mr. Patterson stated that there is also a clay liner under the synthetic liner and he had not been able to determine the exact cause of the liner bubbles. He suspected that some manure had leaked under the liner during the removal of some pipes and as the manure decomposed, the gases caused the liner bubbles. Mr. Patterson explained that the facility removes the bubbles by placing some piping under the liner in the approximate location of the bubble and the gases then exit. He also said that he had been in touch with several experts that advised him that the liner bubbles were not dangerous or a threat, although they cause a loss of capacity in the pond. The facility has contemplated installing another holding pond with a concrete liner and then removing the synthetic liner from this Holding Pond.

IMGP1483: Manure Pond has a loss of capacity due to large bubbles in the liner.

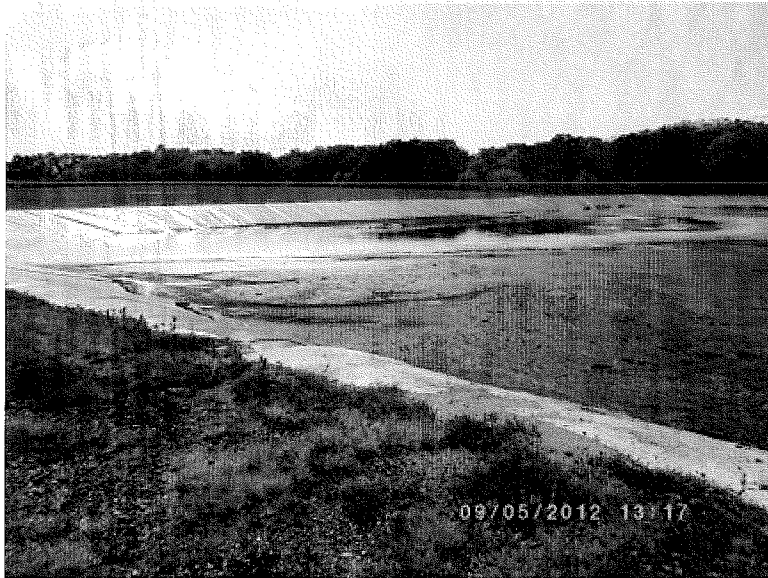
IMGP1484: Mr. Patterson states that he has discussed the liner bubble problem with experts and has been told it is not a major concern.

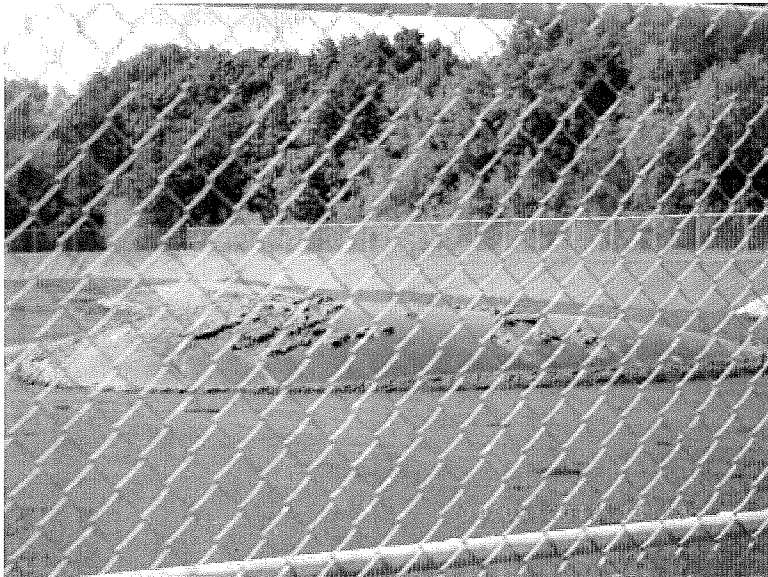
IMGP1489: Large liner bubble in Manure Pond liner. Mr. Patterson suspects the bubbles to be caused by some manure that got below the liner during a pipe removal process in 2011.

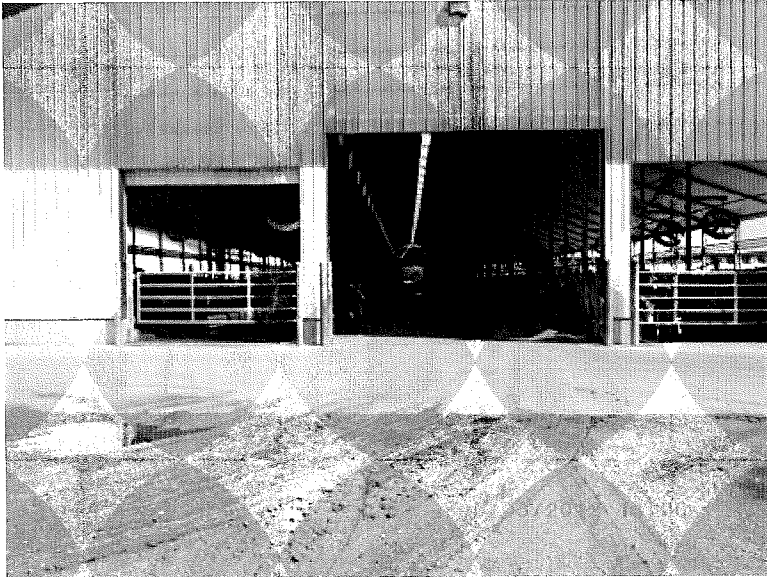
IMGP1494: Looking into South Barn. Track in and track out of manure and feed is kept at a minimum but no curbing to prevent the flow of process wastewater from flowing off the concrete pad to the west. No channelization or discharge was observed on the day of the inspection.

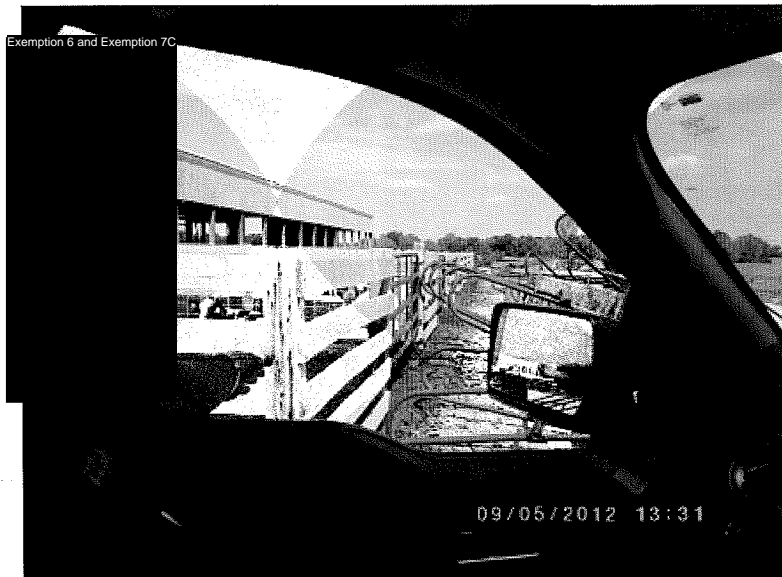
EPA observed the Heifer Barn at the south end of the facility. This barn has attached open lots and confines approximately 100 heifers. There are no gutters on this barn to prevent precipitation from the roof from flowing down onto the open lots. Runoff from the open lots would flow to a vegetated area to the southeast.

IMGP1498: Heifer Barn confines approximately 100 heifers and has open lots attached. There are no gutters on this barn.

1. It is recommended that eave gutters be installed to divert clean water away from the earthen lots for the heifer barn at the dairy complex.
2. In order to better control runoff from the concrete manure storage structure for the heifer barn at the dairy complex, it is recommended that concrete curbing be installed.
